National Register of Historic Places Registration Form

Historic Name: King-Woods Farmstead
Other name/site number: King-Woods Farmstead
Name of related multiple property listing: NA

Street & number: 920 E Court Street
City or town: Seguin State: Texas County: Guadalupe
Not for publication: ☐ Vicinity: ☐

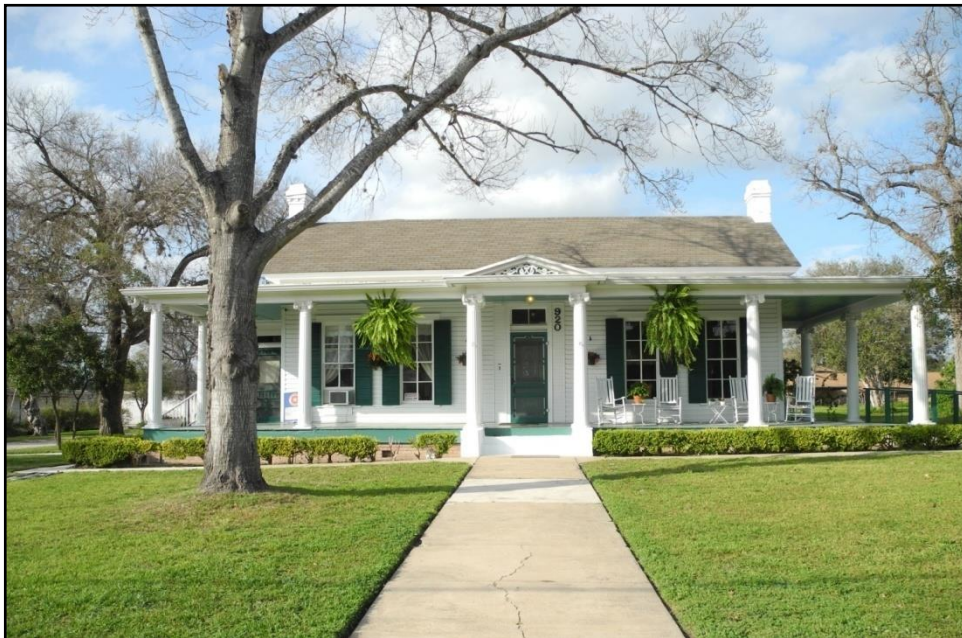
PHOTO 1: King-Woods House, south elevation, camera facing north (February 1, 2017).

The front façade has a symmetrical AABAA arrangement with a central entrance flanked by two window openings on each side. The entrance contains a single entry door topped by a two-light transom window. Vertical bead board panels used as infill are found to either side of the door, suggesting that the door opening was reduced in size—

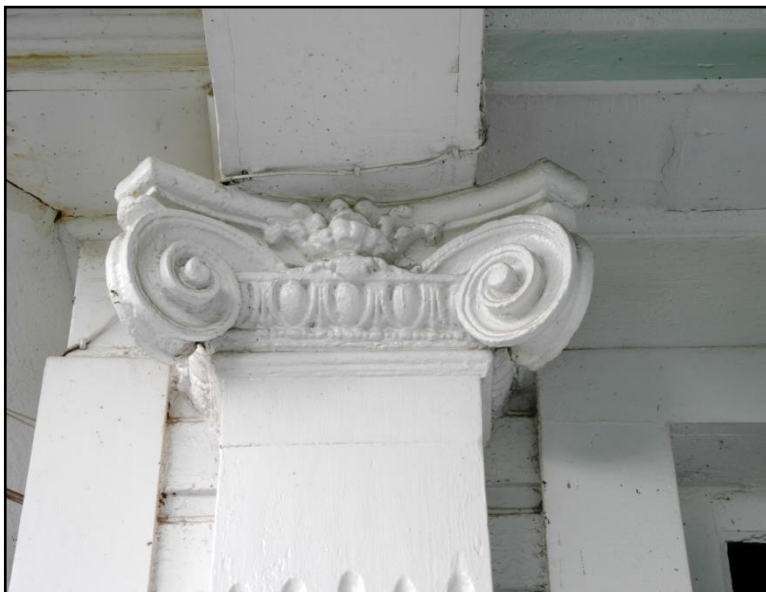
PHOTO 8: King-Woods House, capital on pilaster (west elevation), facing east (February 1, 2017).

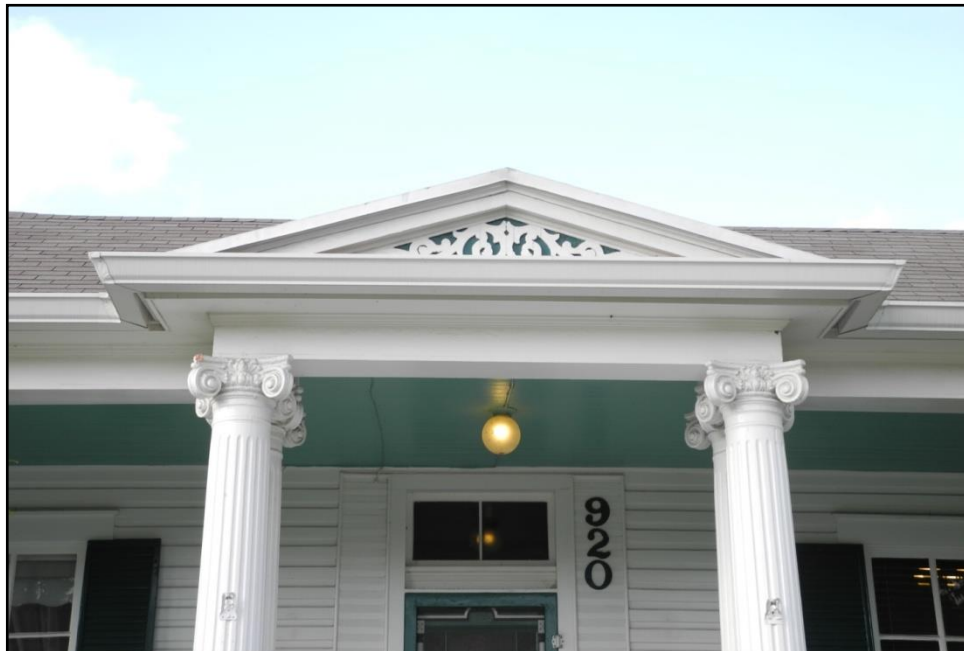
PHOTO 9: King-Woods House, pediment at entrance, south elevation, facing north (February 1, 2017).

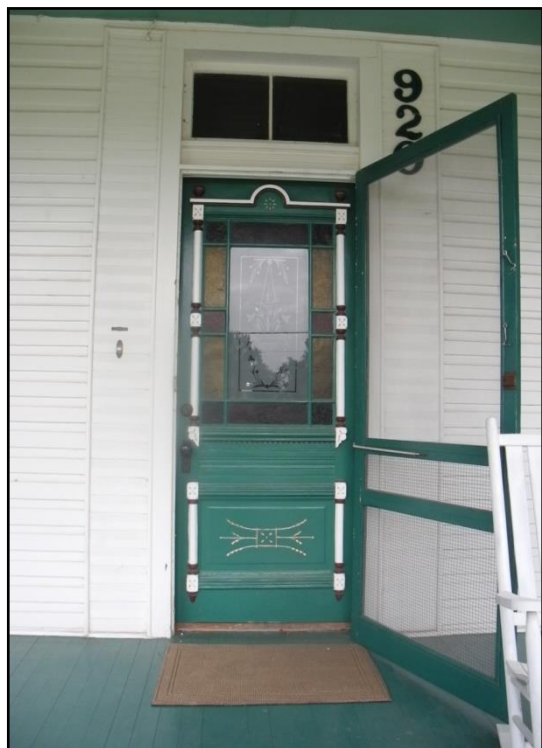
PHOTO 10: King-Woods House, front door, facing north (February 1, 2017).

likely in 1893 when the house was remodeled to its Neoclassical appearance. The door and transom openings are framed with flat trim. The door itself is highly elaborate, with a bottom panel containing a decorative intaglio carving and a large window with etched glass in its center and leaded and stained glass lights in a 3" rectangular border around its edges (Photo 10). On either side of the window and bottom panel are carved spindles with alternating cylindrical and blocky shapes. Delicate sawtooth trim underlies the window, and the knob backplate is cast iron with carved floral motifs. A plain, historic-age wood screen door is attached to the exterior. The four window openings on this primary façade have tall, narrow, 4/4 double hung wood windows, louvered shutters, and wide wood trim with a molded strip along the top. The siding on the front elevation is wood drop siding with a thin decorative bead between each lap.

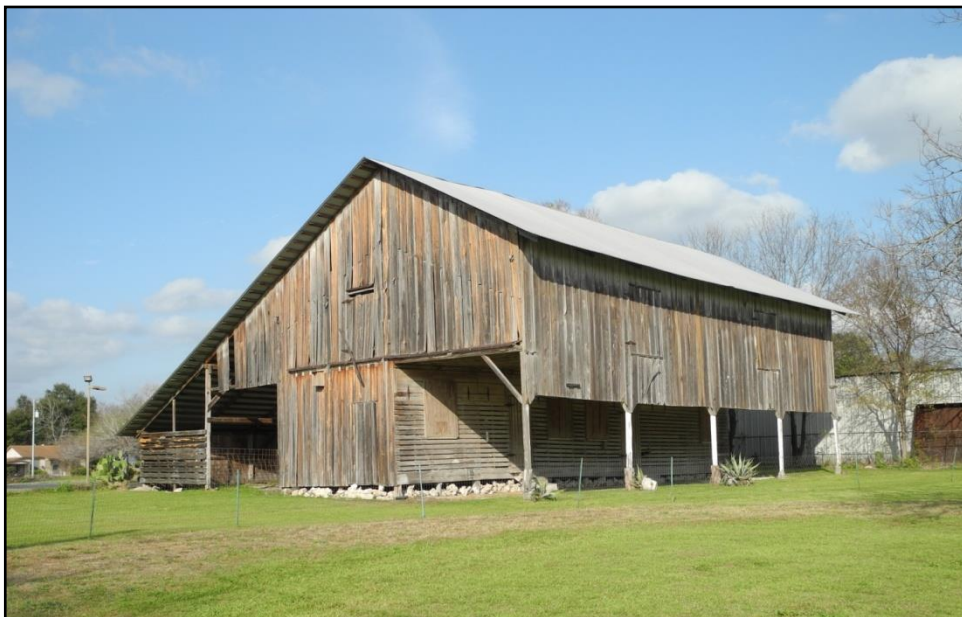
PHOTO 11: King-Woods Multi-purpose Barn, c. 1895, west and south elevations, facing northeast (December 10, 2016).

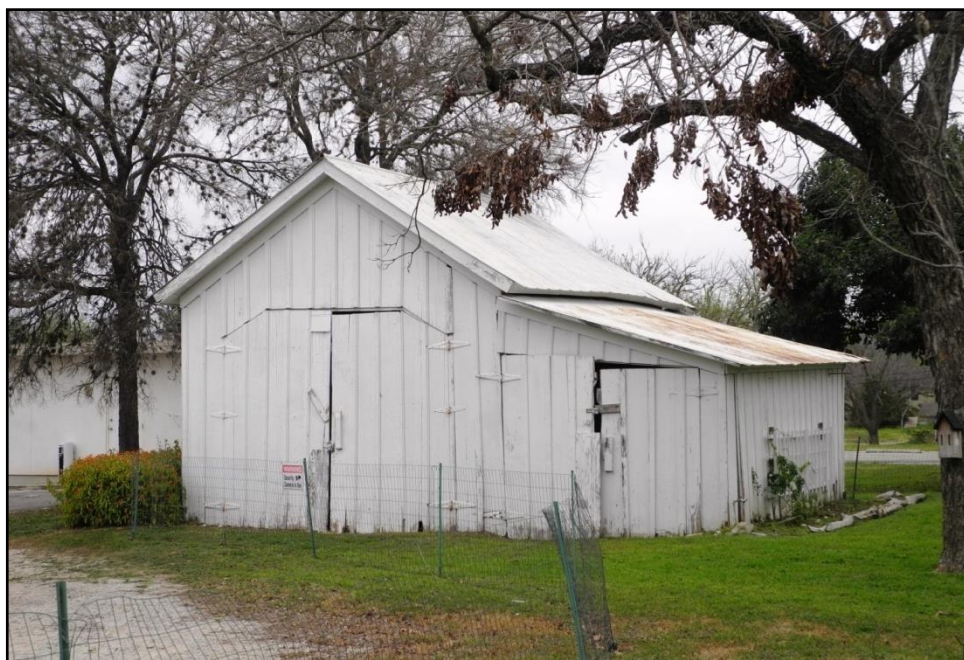
PHOTO 14: King-Woods Buggy House, c. 1890 with c. 1920 addition, south and east elevations, facing north/northwest (February 1, 2017).

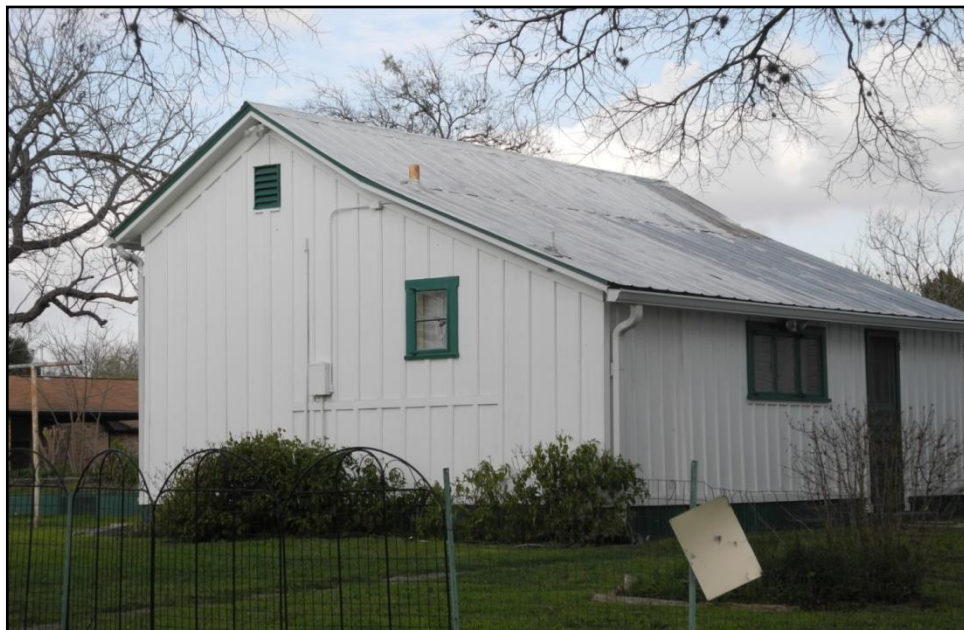
PHOTO 15: King-Woods Kitchen/Smokehouse, c. 1895 with c. 1935 addition, east and north elevations, facing southwest (February 1, 2017).

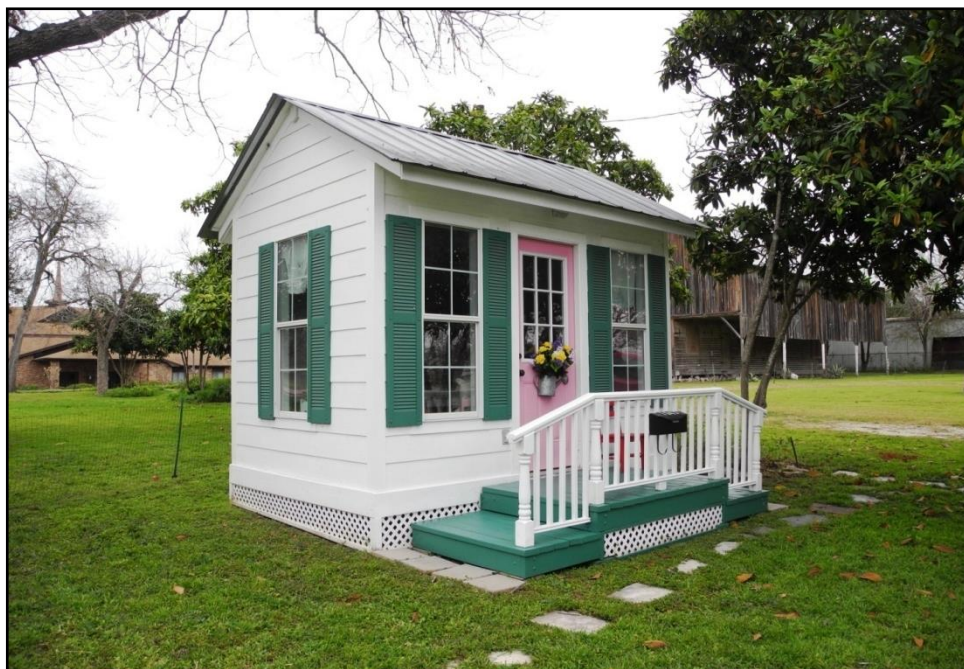
PHOTO 18: Playhouse, 1947, west and south elevations, facing northeast (April 23, 2017).

The playhouse is located approximately 35 feet east of the house near the yard's decorative kumquat trees. It is a small wood frame side-gabled building with a footprint measuring approximately 10 by 8 feet (Photo 18). Its siding is asbestos and its roof is standing seam metal. Exterior walls have plain fascia and corner boards and flat window and door trim. The narrow bargeboards on the gabled side elevations have small wood "keystone" details. The building sits on a slightly raised foundation and its front elevation has a "Charleston" porch with wide, low steps accessing both sides. Along the front of the porch is a balustrade with turned and square banisters. The foundation is skirted with lattice.

The front elevation is symmetrical, with a central door flanked by two windows. The door is a non-historic replacement with two panels in the lower section and nine rectangular lights in the upper section. The west side elevation has a single window opening. All three windows have fixed wood shutters, replacement vinyl sash, and metal screens. The east side elevation and rear are windowless. Inside, the playhouse has a single room with a vaulted ceiling that follows the roof form. The floor is wood and the walls are smooth and painted.

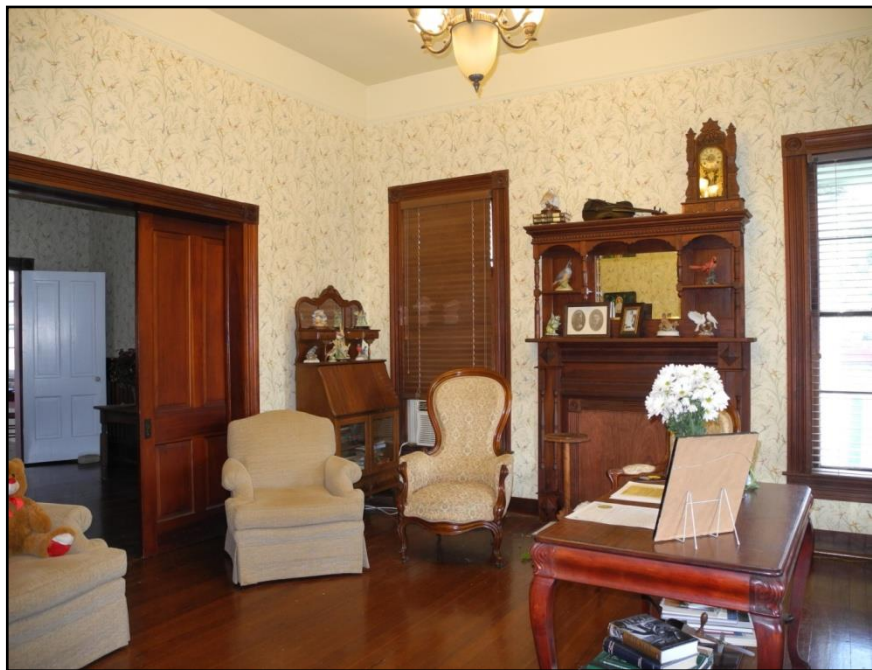
PHOTO 21: King-Woods House, parlor (1887) facing northeast (W.C. Kisbaugh mantel c. 1908) (December 10, 2016).
